EXCEL Environmental Resources, Inc.

INDEPENDENT COMMUNITY MONITORING

REPORT No. 6

Monitoring Period: Monday, May 5th, 2025 through Friday, June 13th, 2025

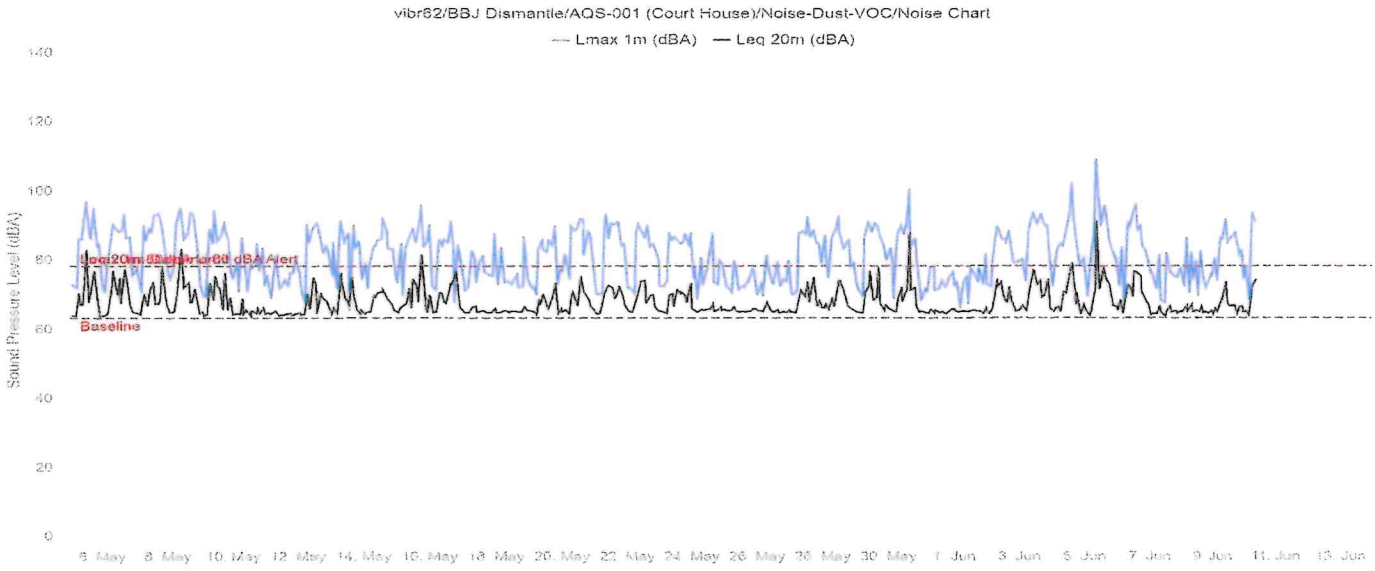
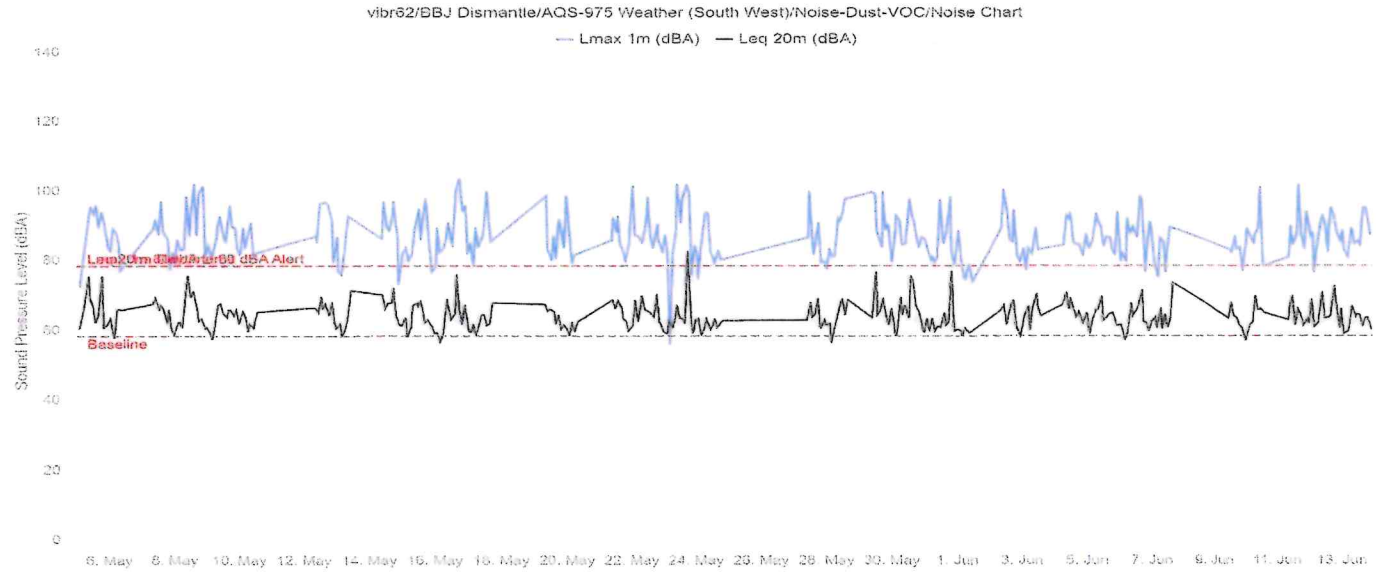
AQS-001 (Court House) Noise Monitor - 5/5/25 to 6/13/25

- **AQS-001 (Court House)** - As shown in the noise monitoring graph on Page 6 of 19 of the Data Summary Report, there were multiple Lmax- 1min (blue line) and Leq- 20 min (black line) exceedances of the 80 dBA alert level spread out over the reporting period.

- Review of the daily equipment status and excursion reports prepared and provided to Excel by Gramercy indicates that the exceedances were caused by courthouse activities and were not related to the dismantling, or heavy equipment operation at the Site.

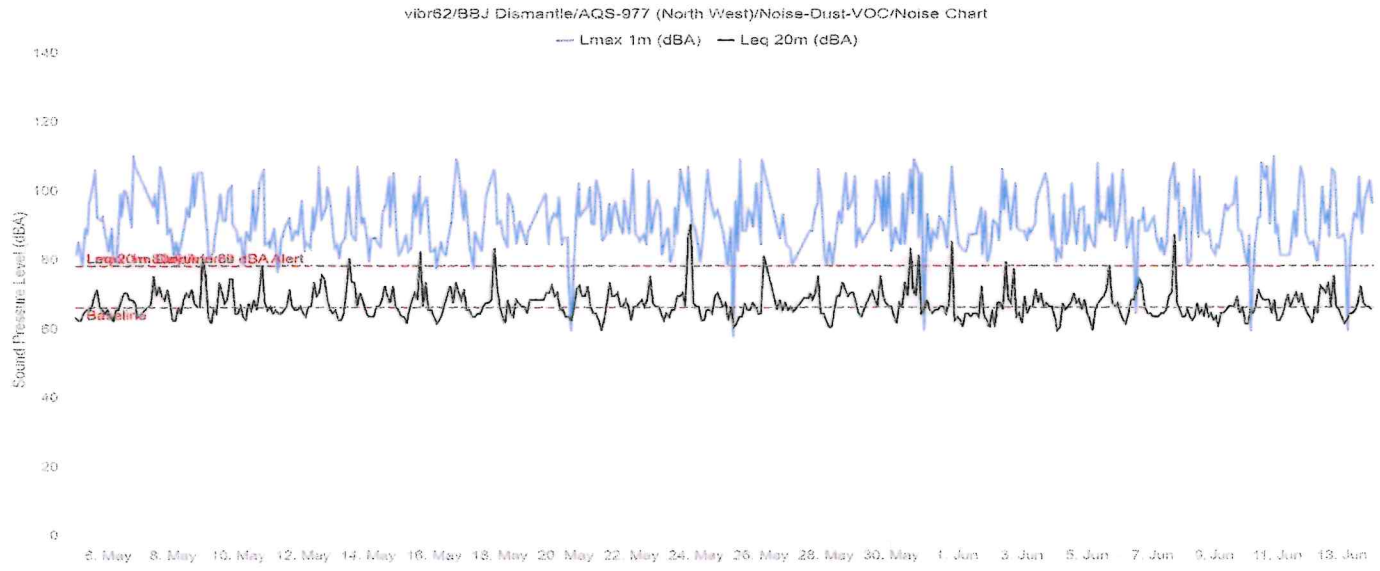
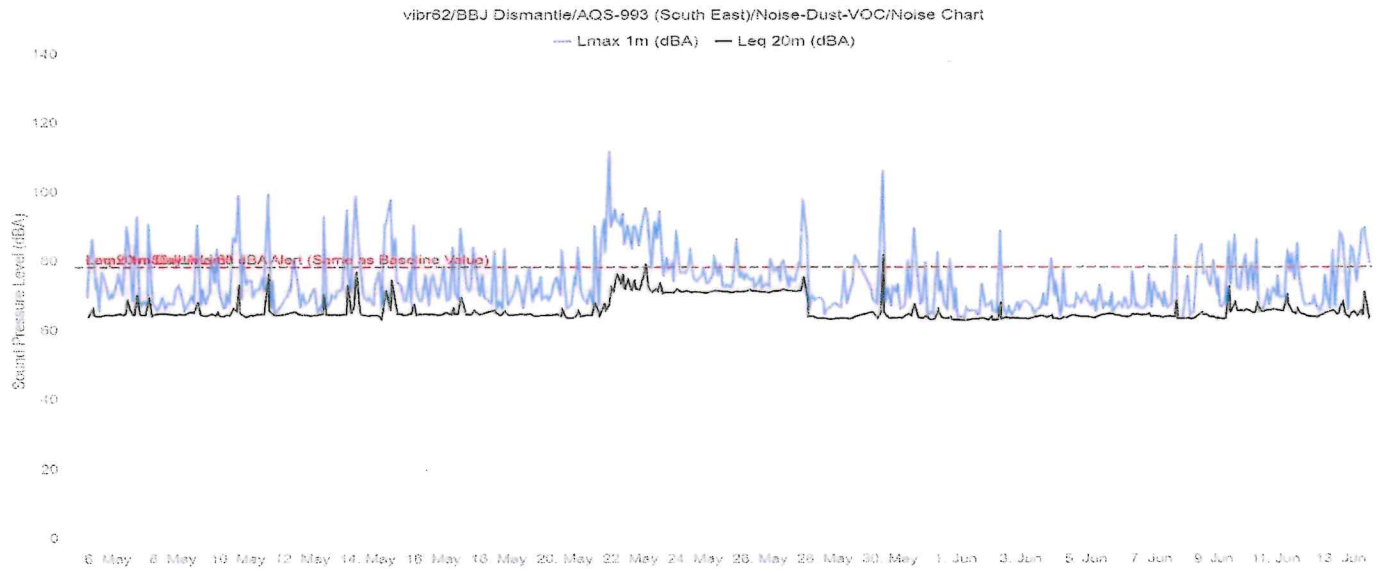
AQS-977 (North West) Noise Monitor - 5/5/25 to 6/13/25

- **AQS-977 (Northwest on Centre St.) -** As shown in the noise monitoring graph on Page 7 of 19 of the Data Summary Report No. 6, there were multiple Lmax- 1min (blue line) and significantly fewer Leq- 20 min (black line) exceedances of the 80 dBA alert level spread out over the reporting period.

- Review of the daily equipment status and excursion reports prepared by Gramercy indicates that the noise exceedances are not related to onsite activities.

- **AQS-993 (Southeast on Baxter St.)** - As shown in the noise monitoring graph on Page 7 of 19 of the Data Summary Report No. 6, there were multiple Lmax- 1min (blue line) and significantly fewer Leq- 20 min (black line) exceedances of the 80 dBA alert level spread out over the reporting period.

- Review of the daily equipment status and excursion reports prepared by Gramercy and provided to Excel indicates that the noise exceedances were caused by traffic on Baxter Street and are not related to onsite activities.

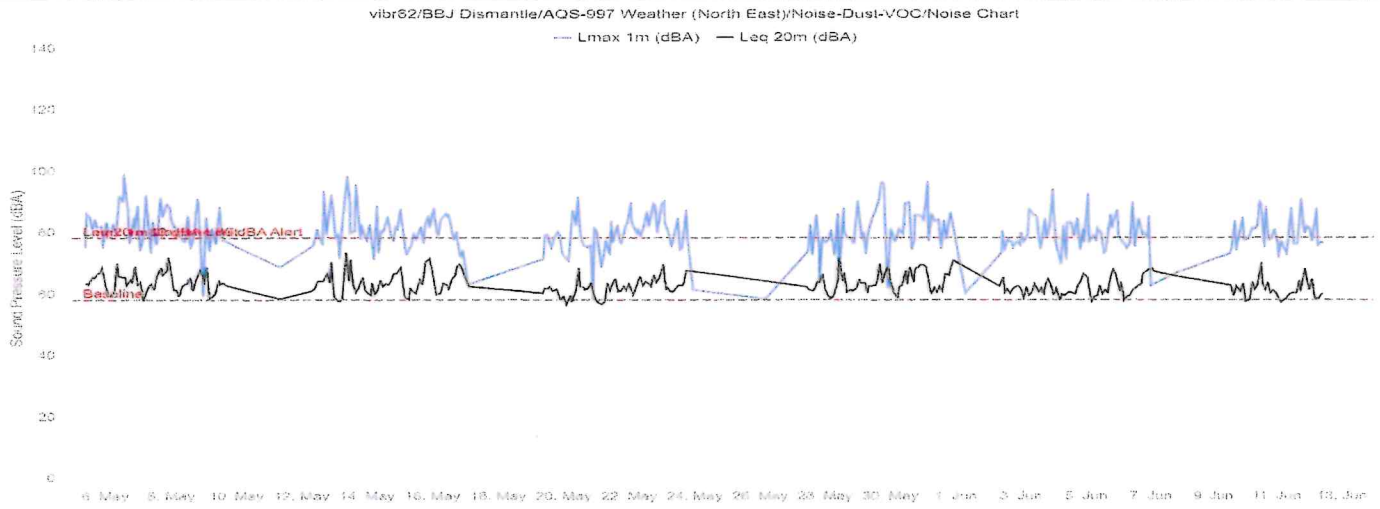
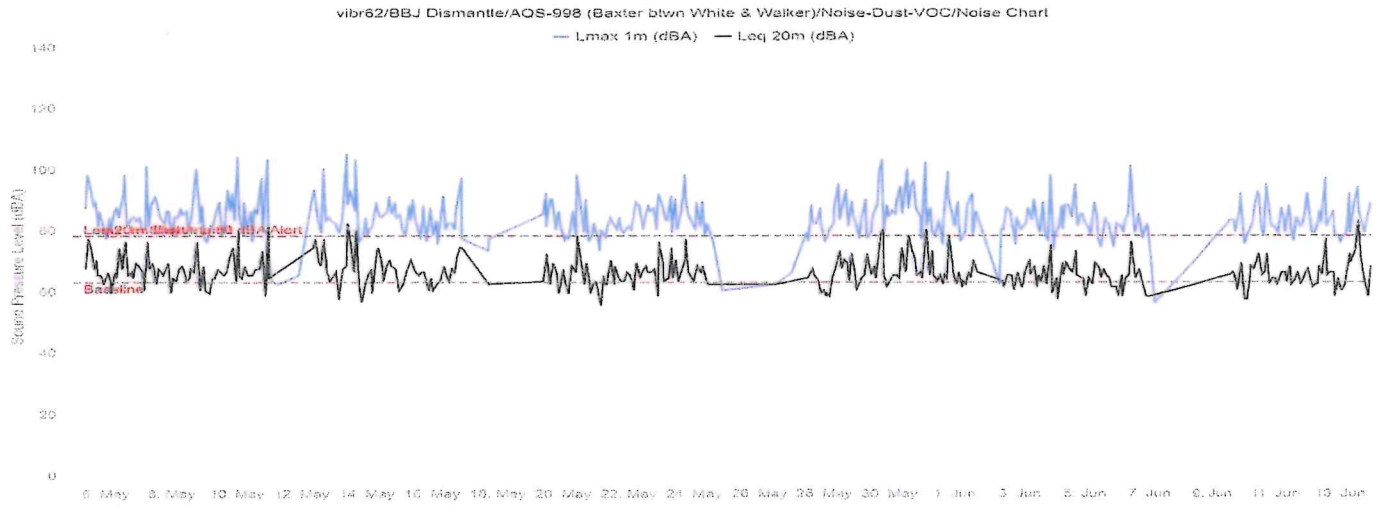
AQS-997 Weather (North East) Noise Monitor - 5/5/25 to 6/13/25

- **AQS-997 (Northeast on Baxter St.)** - As shown in the noise monitoring graph on Page 8 of 19 of the Data Summary Report No. 6, there were multiple Lmax- 1min (blue line) with significantly fewer Leq- 20 min (black line) exceedances of the 80 dBA alert level spread out over the reporting period.

- Review of the daily equipment status and excursion reports prepared by Gramercy and provided to Excel indicates that all the exceedances were caused by traffic on Baxter Street are not related to onsite activities.

- **AQS-998 (Baxter St. between White and Walker)** - As shown in the noise monitoring graph on Page 8 of 19 of the Data Summary Report No. 6, there were multiple Lmax- 1min (blue line) with significantly fewer Leq- 20 min (black line) exceedances of the 80 dBA alert level spread out over the reporting period, however, review of the daily equipment status and excursion reports prepared by Gramercy and provided to Excel indicate:

- Review of the daily equipment status and excursion reports prepared by Gramercy indicates that the noise exceedances are not related to onsite activities.

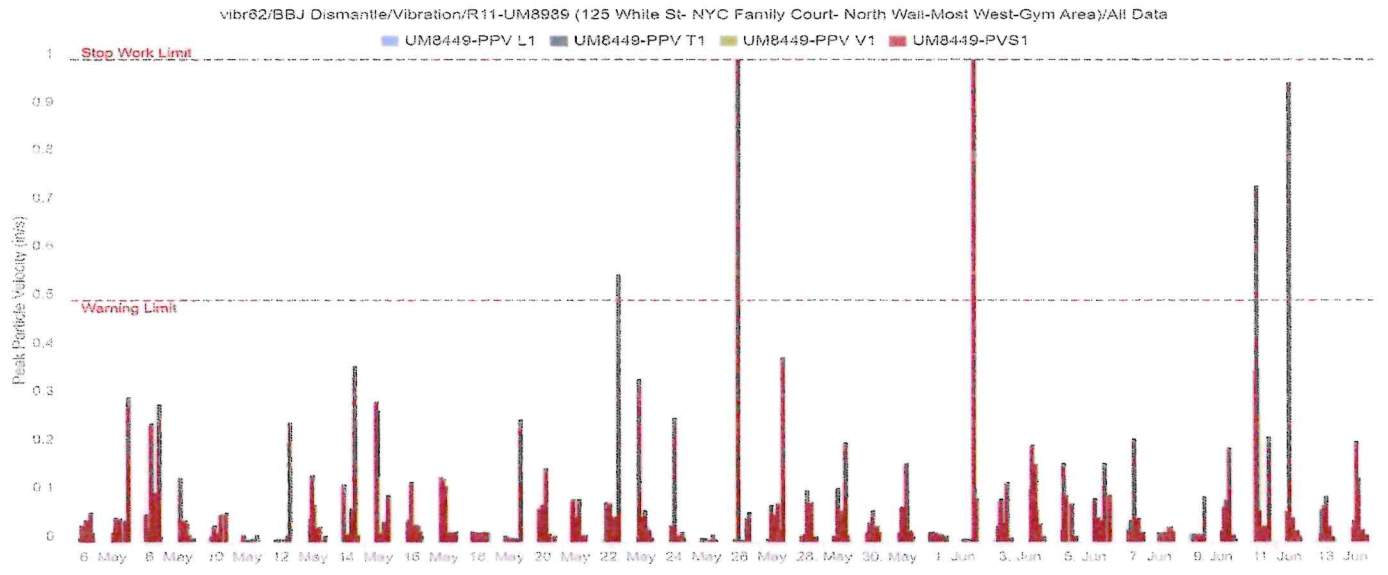
Vibration Monitor R11 - 5/5/25 to 6/13/25

- There were two vibration exceedances recorded at Monitor R-11 on Sunday, May 25th, 2025 and Sunday, June 1st, 2025 when there was no work being conducted at the Site therefore this noise level exceedance is related to courthouse activity and/or traffic.
        - There was one vibration exceedance recorded at Monitor R-17 on Tuesday, May 13th, 2025, and one on Thursday, June 3rd, 2025.

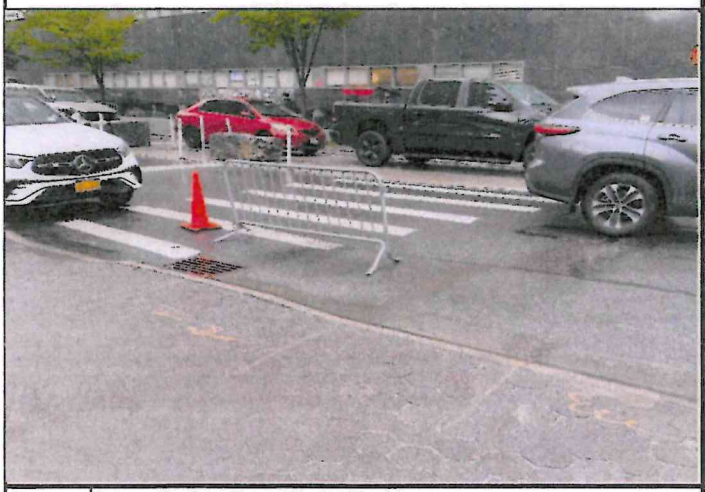
➢ M. DeMatteo visually inspects the sidewalk and roadway opposite the Site entrance/exit for any visible sign of dust/particulate tracking offsite. Although it had been raining and the sidewalk and pavement was visibly wet with some puddled water, there was some visible soil/crushed concrete on the sidewalk in the immediate vicinity of the gate as shown in Photo No. 1 provided in Data Summary Report No. 6, however, there was no visible indication of tracking into the roadway. (**See Photos No. 1 through 4 of the Data Summary Report No. 6**).

Photo 4: View of the sidewalk and Centre St. looking south towards the courthouse and CAMP station AQS-975.

- Ensure frequent inspection and routine maintenance, as needed, of the onsite truck/equipment tracking pad to ensure that crushed concrete/soil is not tracked off the Site onto the adjacent sidewalk or roadways.
